**Baltimore County
National Pollutant Discharge Elimination System
Municipal Separate Storm Sewer System Permit
2024 Annual Report**

**Horacio Tablada, Director
Department of Environmental Protection and Sustainability
December 20, 2024**

**Annual Report of Baltimore County’s
National Pollutant Discharge Elimination System (NPDES)
Municipal Separate Storm Sewer System (MS4) Permit
2024**

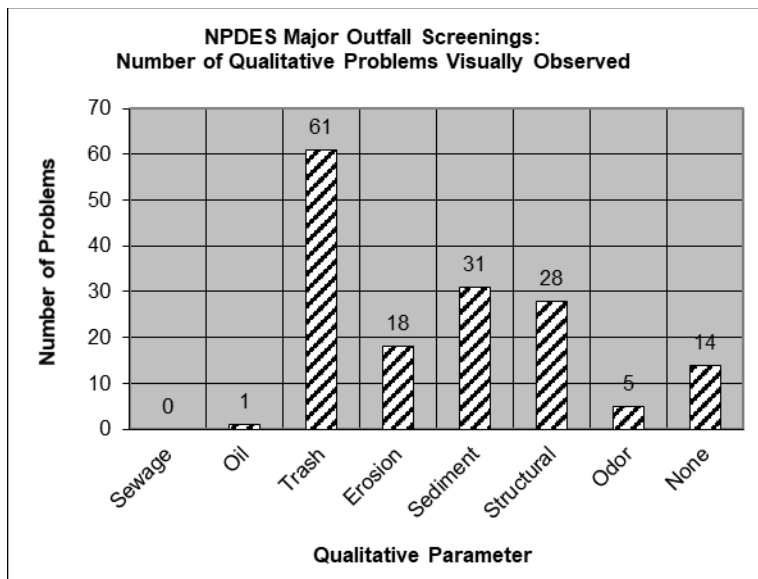
Figure 5-11 and Figure 5-12 illustrate incidences of problems observed during *qualitative* assessments such as; visual evidence of sewage, oil, and structural problems. Qualitative and “visual problems” which were those most frequently encountered included observations regarding color, odor, clarity, and receiving water characteristics and sediment deposition immediately at and below each outfall. Trash, erosion, and sediment deposition were observed at 124, 23, and 98 outfalls, respectively. Oil was observed at one outfall and sewage was not observed at any. Structural issues were observed at 59 and odor at nine. Of the total 193 outfalls screened, there were a total of 314 qualitatively assessed problems, however, 24 had no problems. Many of the outfalls screened had more than one problem. Eighty-five percent of the major and 90% of the minor outfalls had a qualitative problem.

Figure 5-11 Major Outfalls Number of qualitative problems visually observed

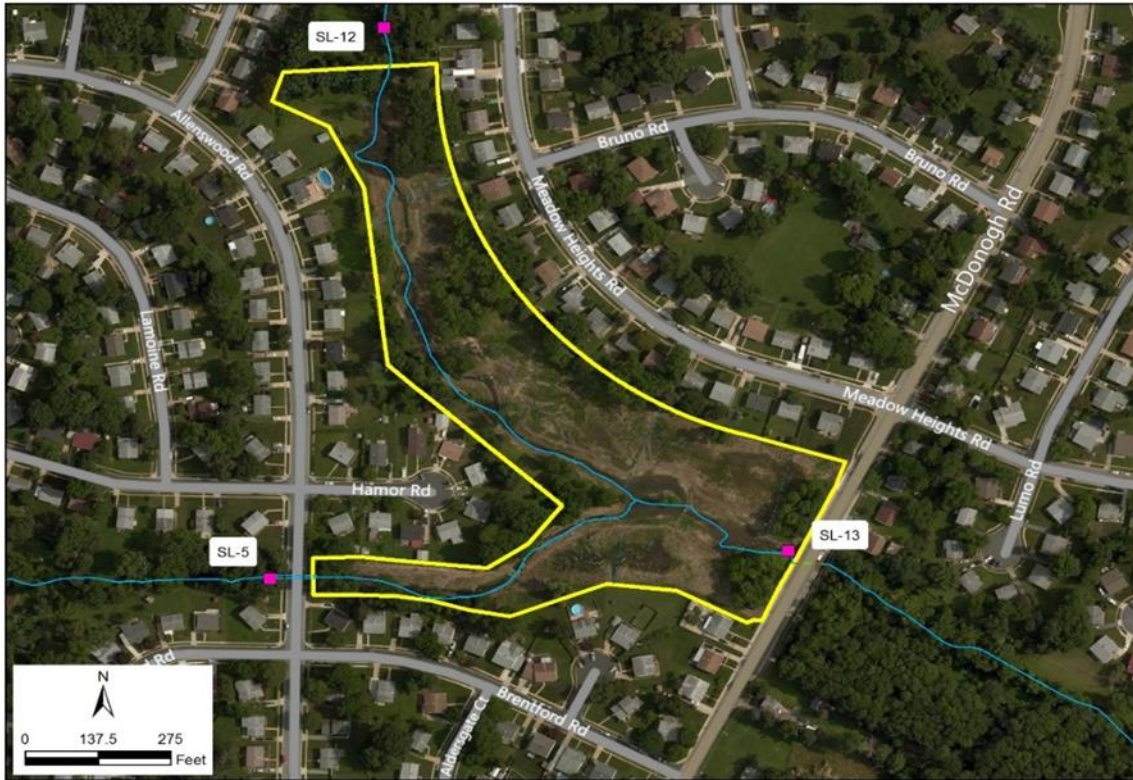
Figure 9-7: Scotts Level Branch McDonough Road Restoration Water Chemistry Monitoring Locations

Figure 9-7 shows the location of the three water chemistry monitoring sites for the McDonough Road restoration project. All three sites are outside the restoration project, with SL-05 being the Allenswood tributary site above the restoration along with SL-12 (Meadow Heights) and SL-13 (McDonough) being the main stem site below restoration.

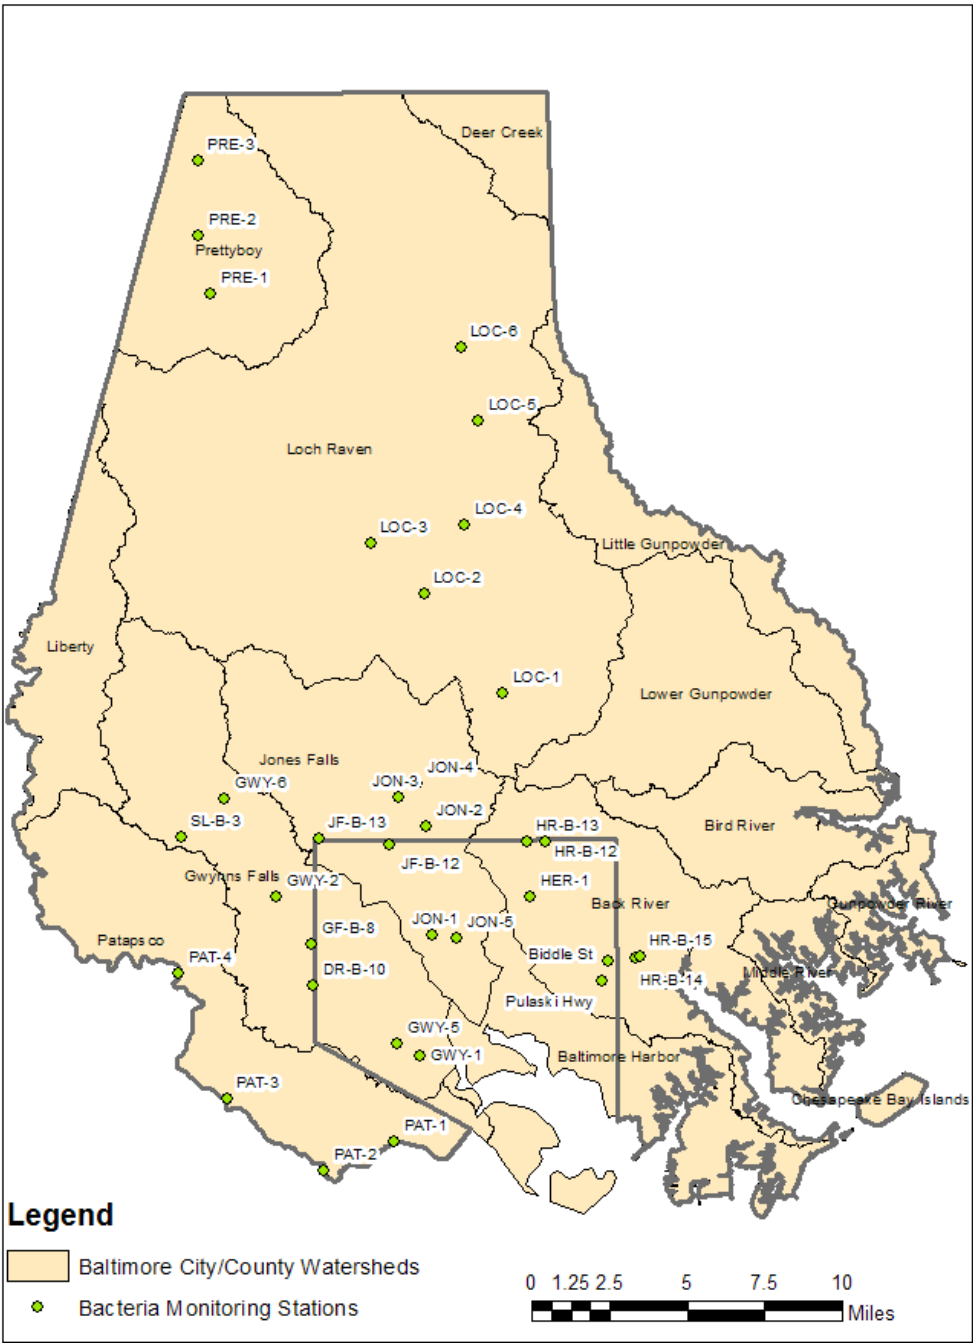
Figure 9-18: Map of Active Bacteria TMDL Monitoring Stations

County, 7 sites in Baltimore City and 5 sites in Carroll County. These were the sites used by Maryland Department of the Environment in the development of the bacteria TMDL. In 2015, 8 new sites were added to the monitoring program, and as of 2020, the sites in Carroll County and Baltimore City are no longer being monitored. All active monitoring sites are shown in Figure 9-18.
